# **LOUISIANA DEPARTMENT OF WILDLIFE & FISHERIES**

**WATERBODY MANAGEMENT PLAN SERIES**

**TURKEY CREEK LAKE**

**LAKE HISTORY & MANAGEMENT ISSUES**

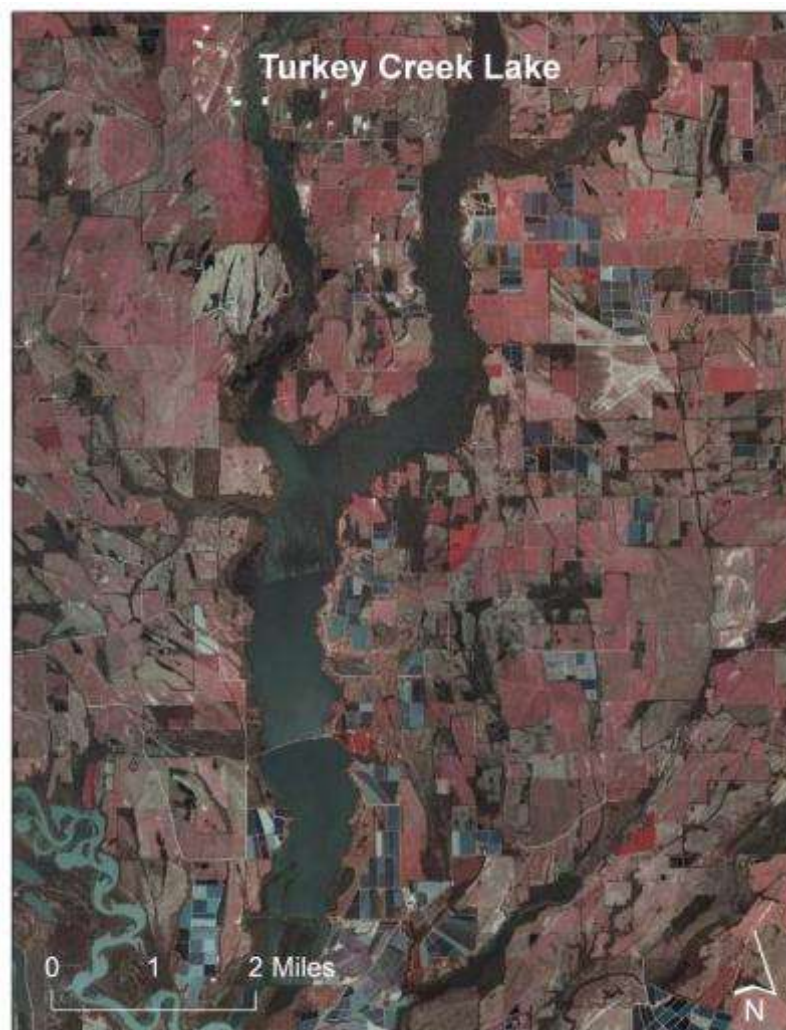
Figure 1. Aerial photo of Turkey Creek Lake, Louisiana.

A total of 3,080 surface acres as shown below in Figure 1.

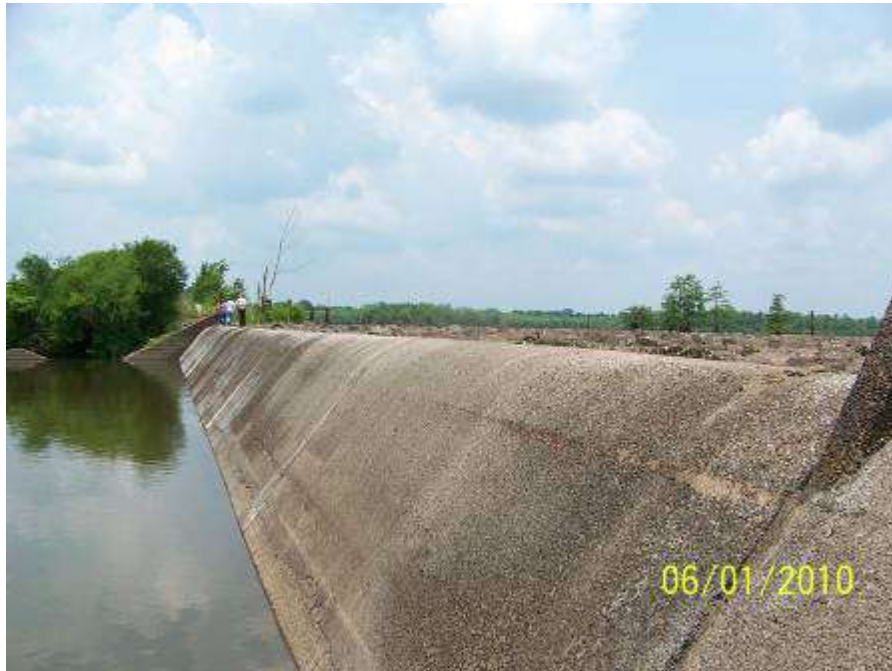
Figure 2. Photo of the Turkey Creek Lake spillway looking west along the dam.

Spillway (Figure 2)

Low crest width = 250 ft.; elevation = 44.0 ft. NGVD

A large portion of the upstream dam embankment has significantly eroded. The crown has narrowed from 20 feet to 6 feet in some locations. The crest elevation is also lower than the recommended height at certain locations. It has been recommended to add appropriate soil to these areas and to provide shoreline protection on the upstream slope. Water has been documented to be leaking from the upper spillway weir (on the east side) for at least a few years. SOURCE: Turkey Creek Dam Inspection Report 2015, prepared by ECM Consultants, Inc. for LDOTD.

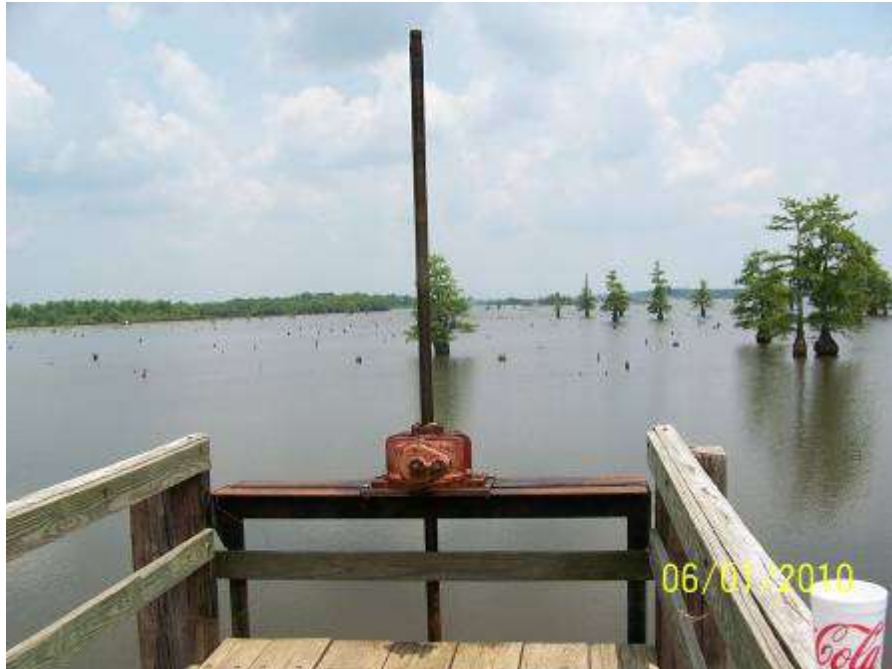
Figure 3. Water control structure located at the dam on the southern end of Turkey Creek Lake, LA.

A photo of the drawdown structure is shown in Figure 3 and the location of spillway and drawdown structure is shown in Figure 4.

Structure – 48 in. gated culvert with manual opening by vertical lift stem and wheel

Number of culverts – 1

Condition – constructed in 1963, functional but severely rusted

Drawdown Capability – approx. 9 ft. total, rate unknown
